# Manhole Inspection Summary

Manhole # S35QQ1020MH

Insp Date: **3/20/07 10:52 AM**

**Location** Address: **416 WINSTON AVE**

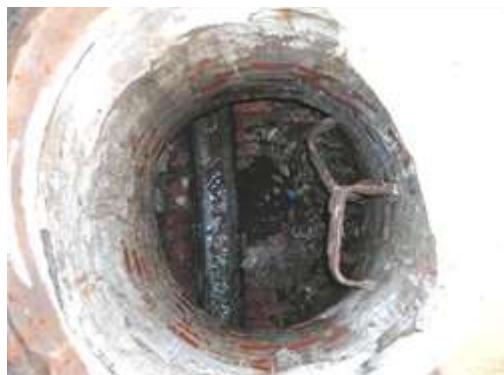
Top View

Corroded steps. Evidence of surcharge - Bench debris.

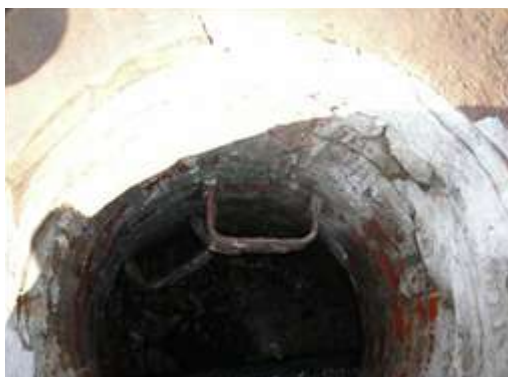
Defect

Frame leaks. Adjustment deterioration and infiltration. Corbel and Barrel infiltration - other side.

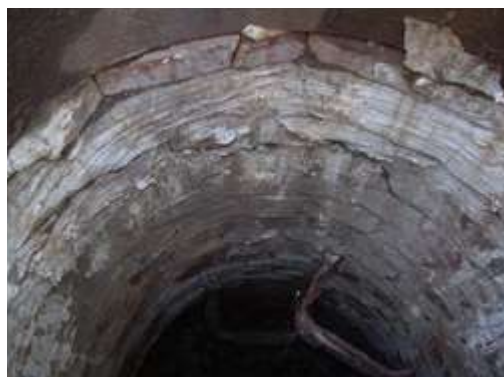
Defect

Frame leaks. Adjustment deterioration and infiltration. Corbel and Barrel infiltration.

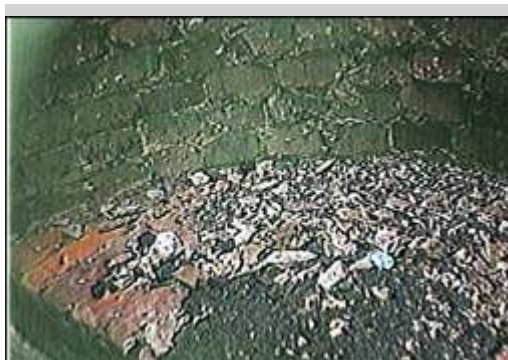
Defect

Barrel deterioration and infiltration.

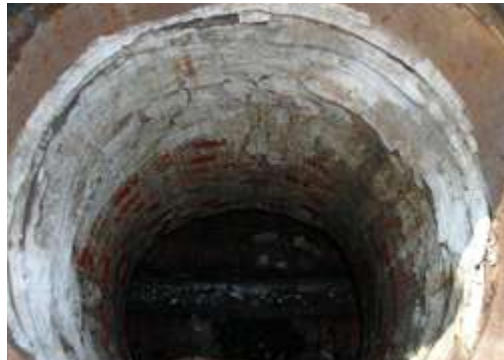
Defect

Frame leaks. Adjustment deterioration and infiltration. Corbel and Barrel infiltration.

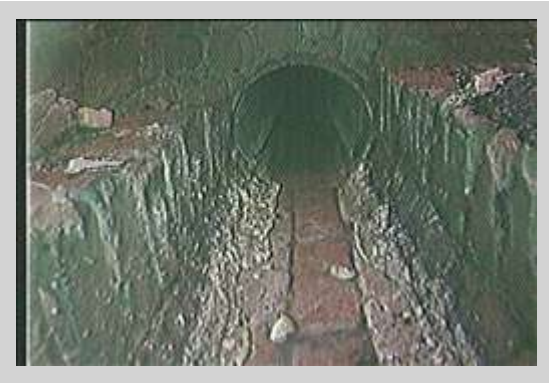
### 8 in. Circular Gravity Sewer Pipe Out @ 12 O'Clock

Barrel deterioration and infiltration. Channel deterioration.

Infiltration: **Evidence** Pipe Seal Cond: **Cracked**

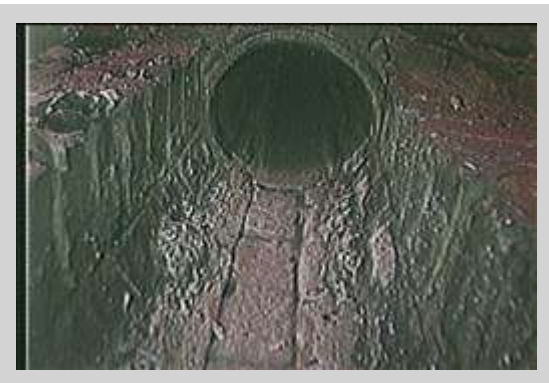
### 8 in. Circular Gravity Sewer Pipe In @ 6 O'Clock

Channel deterioration.

Infiltration: **Evidence** Pipe Seal Cond: **Cracked**
